## Case Study – Rock Anchoring, Gibraltar

- The stabilisation of fault-brecciated limestone cliffs in SW Gibraltar, which had previously suffered serious (15,000m<sup>3</sup>) landslides.

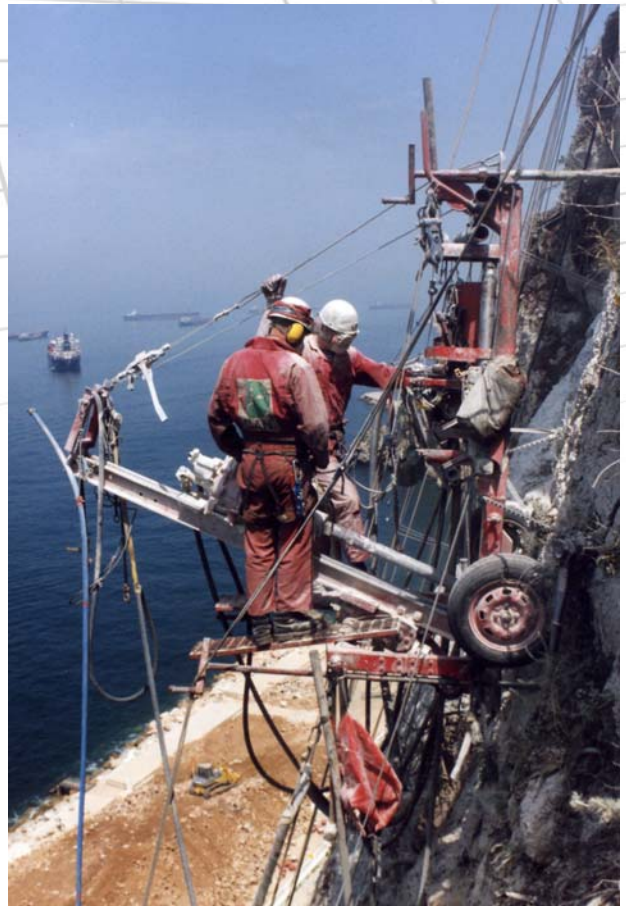
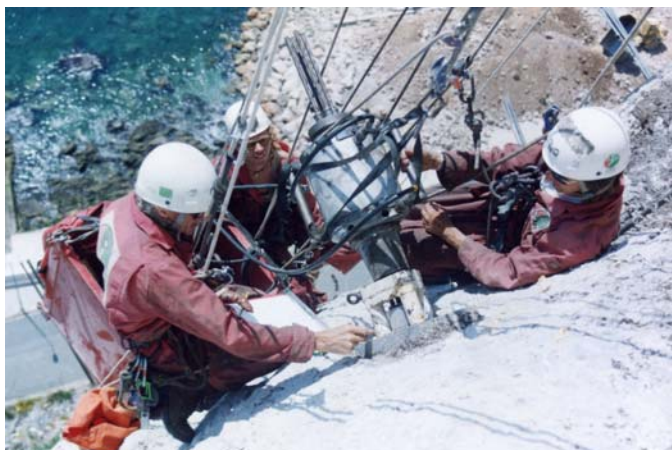
- The challenging access meant that the only economic solution was to use rope access techniques.
- CAN used bespoke drill rigs to facilitate drilling in vertical and sub-vertical locations.
- A requirement to work closely with the engineer to specify anchor length depending on localised ground conditions encountered. CAN then determined the necessary anchor bond length to meet design load criteria.

- DTH drilling systems were used to install 158 multi-strand rock anchors up to 32m in length, with a 500kN working load and typical bond length of 4m. These anchors were cyclically stressed in accordance with the British Standard, and fitted with epoxy-painted, grease-filled head assemblies.
- CAN also used rotary percussive drilling systems to install 154 high yield steel rock bolts with an average length of 7m and 100kN working load. All components were galvanised and anchored with either cementitious grout or polyester resin.
- Other ancillary works included the installation of rockfall netting and application of dry sprayed concrete to infill large fissures.
