Case Study – High Level Rock Catch Fence

- Stabilisation of a 3km length of chalk sea cliff above an under-cliff promenade, as part of a major coastal protection scheme.

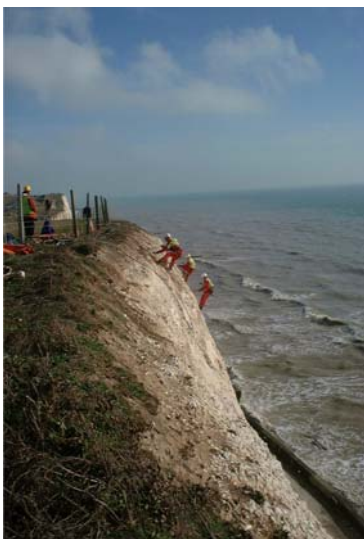
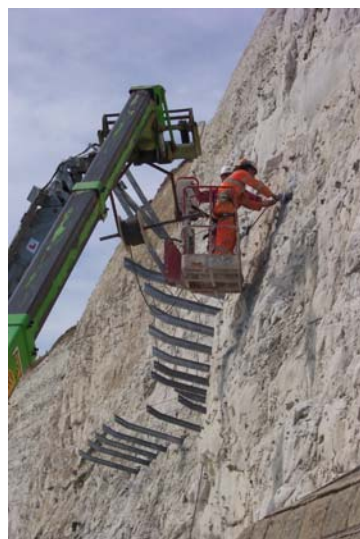
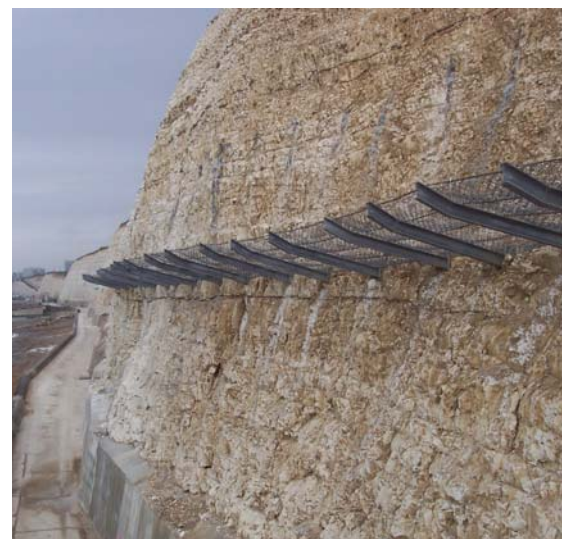
- A comprehensive scaling and block removal exercise was undertaken, yielding hundreds of tonnes of flint and chalk debris.
- Concealed rock bolts, dowels and pigmented sprayed concrete were then installed to provide targeted support measures to discrete chalk flakes / pillars. These measures were designed to mitigate visual impact.
- A high level cantilevered catch fence was installed over approximately 250m length of sea cliff to protect the promenade from rockfall, where the risk was assessed as being high. This was the preferred solution as it was considered to be visually less obtrusive than a larger toe structure or the installation of rockfall netting over the height of the face.
- A combination of rope access, drill baskets mounted on telehandlers and MEWPs were employed to minimise manual handling and accommodate the minimal working width on the promenade.
